TEST REPORT

| SOM_221_2019 |

EXPERIMENTAL DETERMINATION OF THE BREAKING STRENGTH (EN ISO 10545-4) OF A MULTI-LAYER TILE NAMED "SICIS COLLECTION: VETRITE/GEMGLASS", OF THE FIRM "SICIS S.R.L.", RAVENNA (RA) - ITALY.

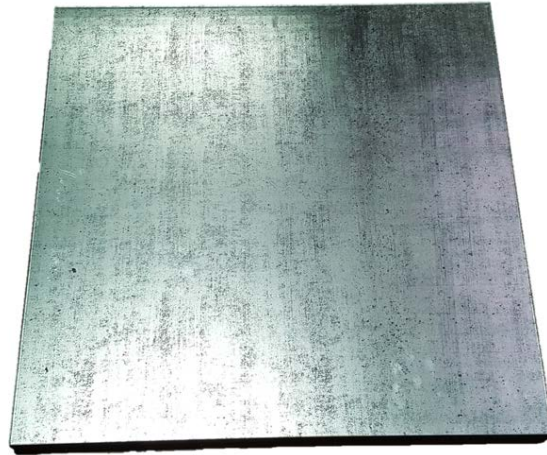
This Test Report describes the determination of the breaking strength of a multi-layer tile for raised access floor, requested to CertiMaC Laboratory in Faenza by the Customer "Sicis S.r.l.", Ravenna (RA), Italy (Offer 19032/lab of 07/02/2019). Tests were performed on 7 samples (600 x 600 x 25 mm) (Figure 1), subjected standard condition (23°C and 50% r.h.) for 7 days.

Figure 1. Tile for raised access floor

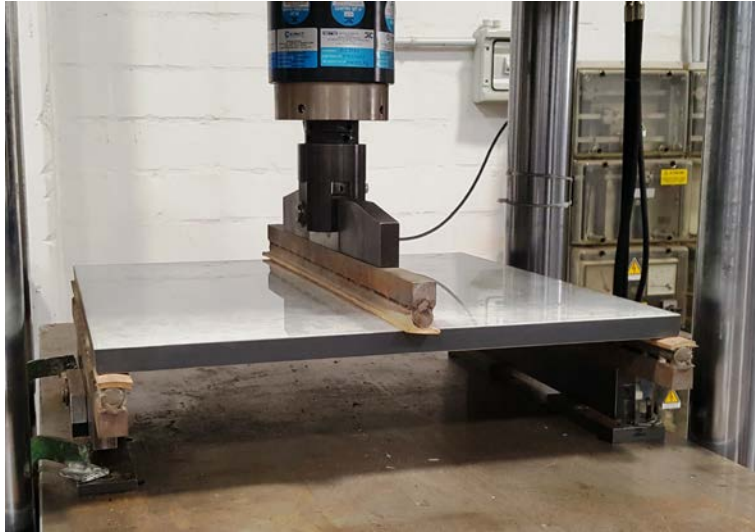
The determination of the breaking strength was performed according to UNI EN 10545-4 standard (Figure 2 and Table 1). Failure modes are reported in Figure 3.

Figure 2. Test lay-out

Sample	Span [mm]	Samples width [mm]	Thickness [mm]	Breaking load [N]	Breaking strength [N]	Modulus of rupture [N/mm ²]
1	580,0	600,00	24,98	14275	13799	33,2
2	580,0	600,00	25,03	15044	14543	34,8
3	580,0	600,00	24,96	14719	14228	34,3
4	580,0	600,00	25,09	13958	13493	32,2
5	580,0	600,00	24,91	15502	14986	36,2
6	580,0	600,00	24,97	14921	14423	34,7
7	580,0	600,00	24,93	14075	13606	32,8
Average				14642	14154	34,0
St.Dev.				564	545	1,4

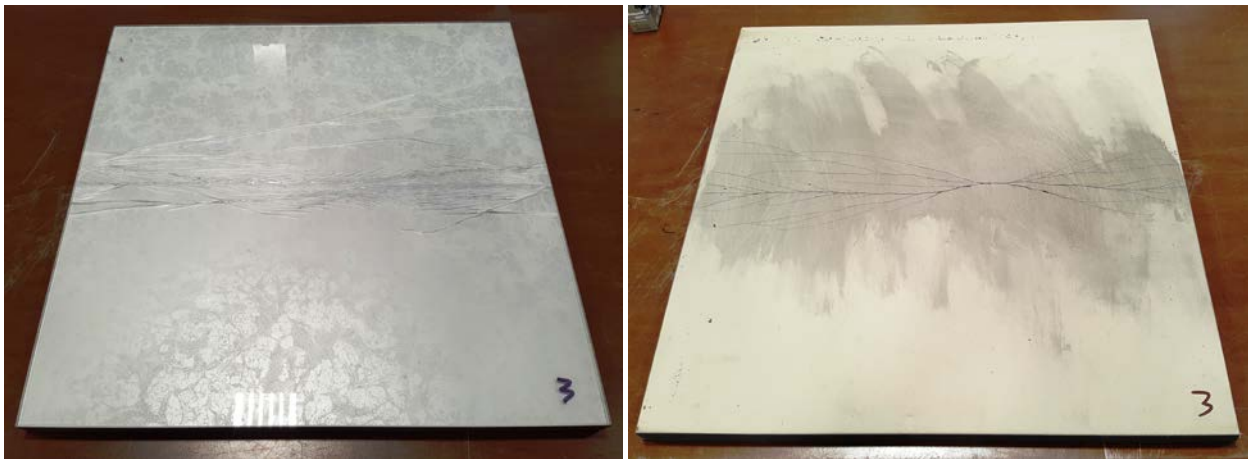
Figure 3. Example of tile fracture (front and back sides)
