TEST REPORT

| **SQM_220_2019** |

EXPERIMENTAL DETERMINATION OF THE STATIC LOAD (EN 12825) OF A MULTI-LAYER TILE NAMED "SICIS COLLECTION: VETRITE/GEMGLASS", OF THE FIRM "SICIS S.R.L.", RAVENNA (RA) - ITALY.

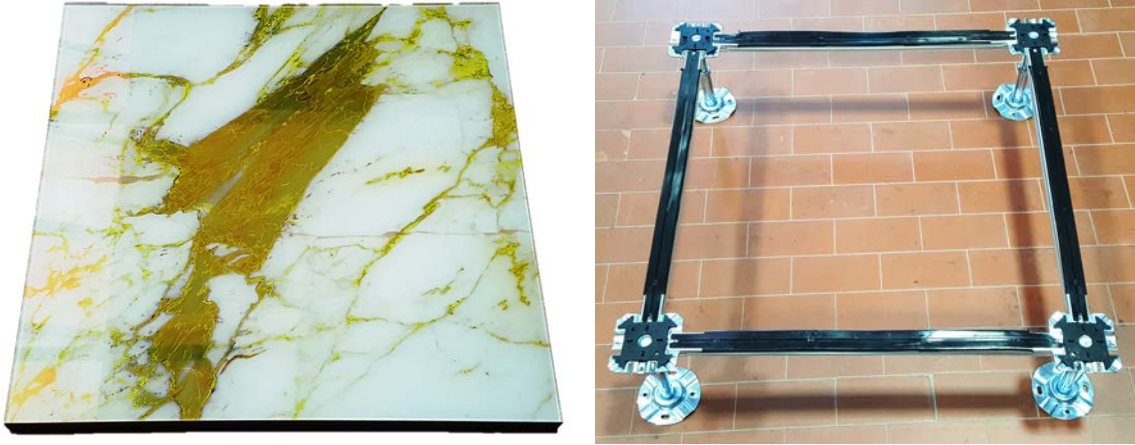
Figure 1. Tile for raised access floor with pedestals and stringers system

This Test Report describes the determination of the static load of a multi-layer tile for raised access floor, requested to CertiMaC Laboratory in Faenza by the Customer "Sicis S.r.l.", Ravenna (RA), Italy (Offer 19032/lab of 07/02/2019). Tests were performed on 4 samples (600 x 600 x 25 mm) (Figure 1), subjected standard condition (23°C and 50% r.h.) for 7 days.

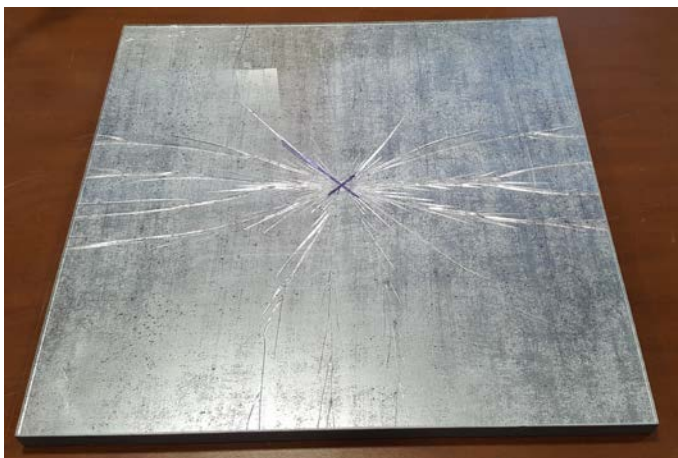
Figure 3. Example of tile fracture (centre and half side tests)

The determination of the static load was performed according to EN 12825 standard (Figure 2 and Table 1). Failure modes are reported in Figure 3.
